Annual Outages 2011

37 days, 22 hours, and 44 minutes

Working like clockwork

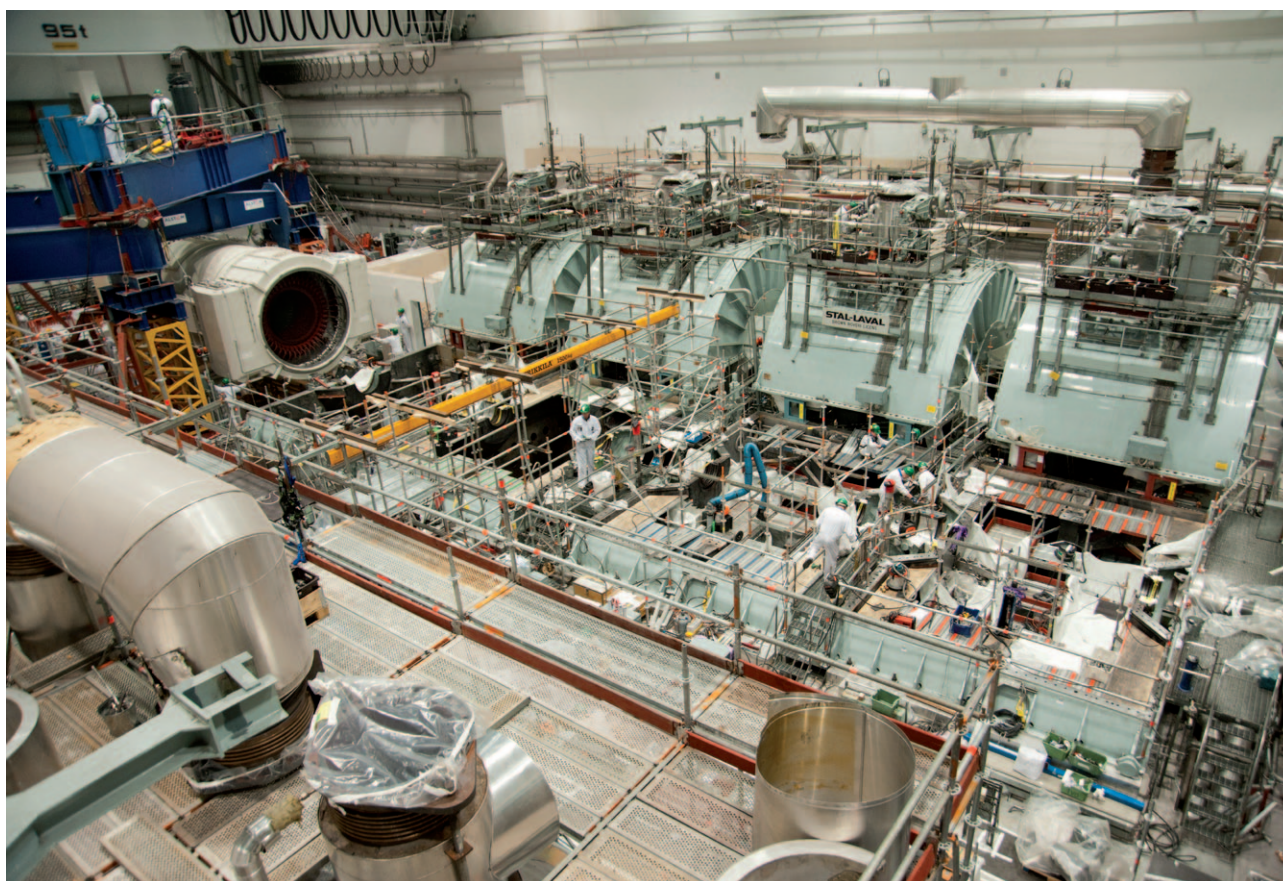
Low pressure turbines; on the left, a stator for the new generator.

- Low pressure turbines: rotor, stator vane, casing and turbine instrumentation replacement.
- Seawater pumps: blade wheel, shaft, inner casing and switch replacement, and renovation of the shut-off valves, electric motors, and hydraulic actuators.
- Replacement of epoxy coated seawater pipes.
- Replacement of inner isolation valves on the main steam lines.
- Renovation of the extraction pipes inside the condenser.
- Generator replacement at OL2. The generator for OL1 will be replaced during the annual outage of 2012. The generator cooling system was replaced at both plant units.
- Low voltage switchgear equipment was replaced. This project will continue during future outages.
- The condensate cooling system I&C was modernised. This project will continue during future outages.

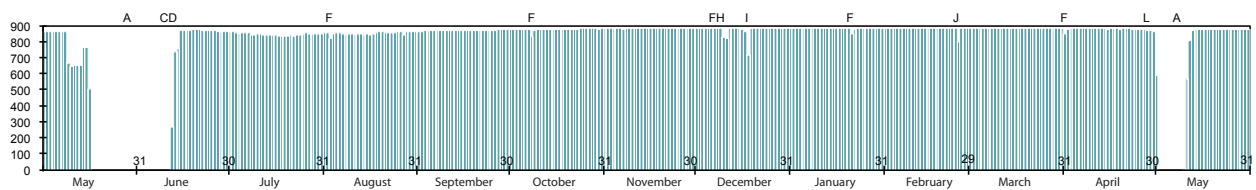
OL1 OPERATION 12 JUNE 2010 TO 1 MAY 2011

A = annual outage
 B = reactor scram after the main steam valves closed
 C = load decrease after a generator cooling system disturbance
 D = feedwater system valve leak repair
 E = blowoff system control valve replacement
 F = periodic test

G = main steam line watering valve leak repair
 H = reheater maintenance hatch seal leak repair
 I = reheater adjustment valve repair
 J = feedwater pump repair
 K = condenser leak repair
 L = coast-down

There were two disturbances causing significant production losses during the operating cycle. During the post-outage power increase on 12 June 2010, the generator was disconnected from the grid due to a cooling system disturbance. The disturbance caused the loss of approx. five hours of production. The second significant disturbance occurred in December, as the plant unit had to be switched to dump operation due to a reheater adjustment valve fault. This disturbance also caused the loss of approx. five hours of production. During the operating cycle, about 17 hours worth of production was lost due to disturbances.

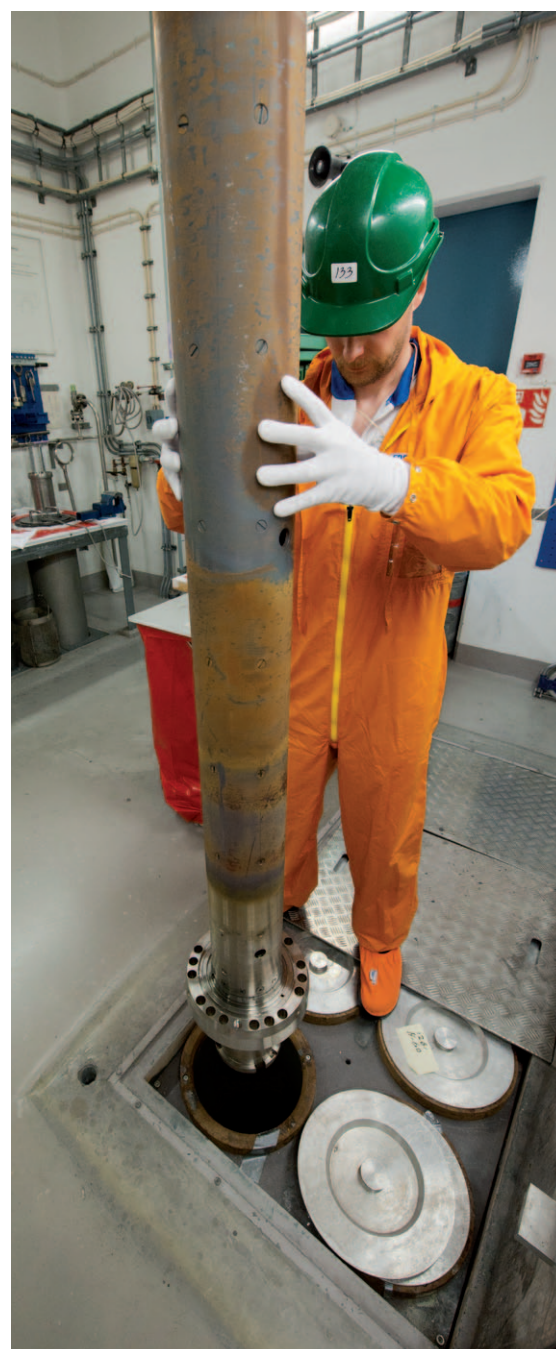
Jussi Juntunen, Sami Mäkinen, and Vesa Laakso from ALSTOM Finland servicing control rod drives in the service facilities.

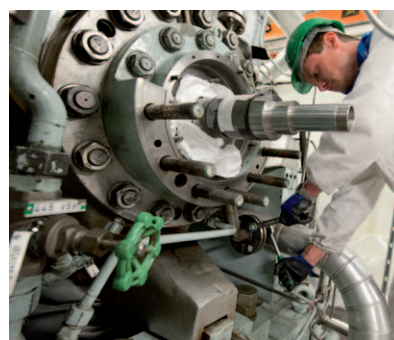
The annual service for the feedwater pump included, among other things, the replacement of the slip ring seal and a complete condition inspection.

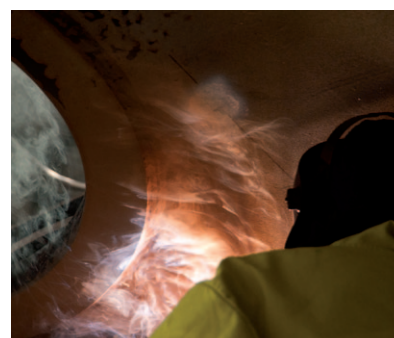
Welding was performed around the neck of the low pressure turbine case.

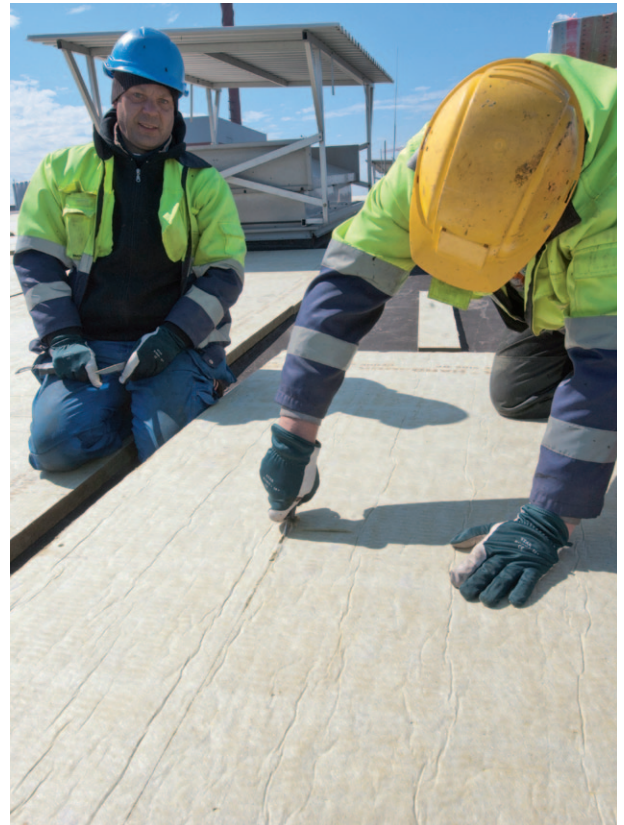
The roof of the OL2 turbine building was serviced during the outages in 2011.

During the annual outage for OL2, two significant construction projects were executed with respect to the turbine building. The most significant maintenance work was performed on the roof of the turbine building. The entire roof, totalling 3,300 square metres, was repaired by installing a new middle layer and a double felt on top of the old bitumen roof. All the roof drains and inclinations around them were repaired. It is expected that the roof will not require more repair for 15 to 20 years.

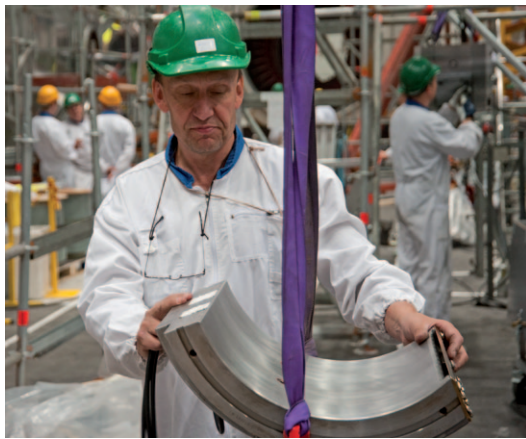
A turbine bearing segment has been inspected and cleaned thoroughly before being transferred into place.

In the refuelling outage for OL1, the most important task that was planned in advance was opening turbine bearing number 4, after which the decision was taken to open bearings 3 and 5. In the bearing inspection, it was discovered that the bearing surface of the lower bearing segments had partially deteriorated to the trailing surface, and it was decided that all lower bearing segments in bearings 3 to 5 will be replaced with new spare segments. In addition, one dump valve was serviced, and other service and inspection tasks were carried out according to the preventive maintenance programmes.

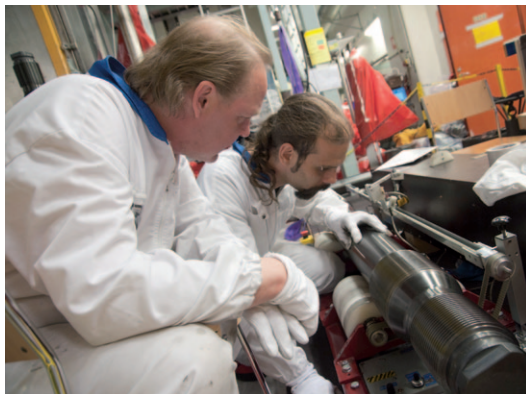
Reactor pressure vessel lid bolts are carefully inspected.

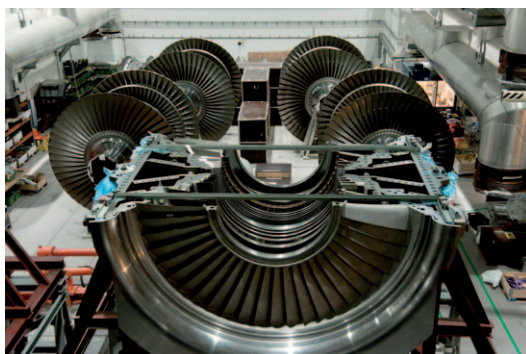
In the foreground, a low pressure turbine case; in the background, rotors.

In the OL2 service outage, new low pressure turbines were installed (RETU project). The project replaced the inner casings, blade supports, and rotors of all the low pressure turbines. Other work performed in the project included the

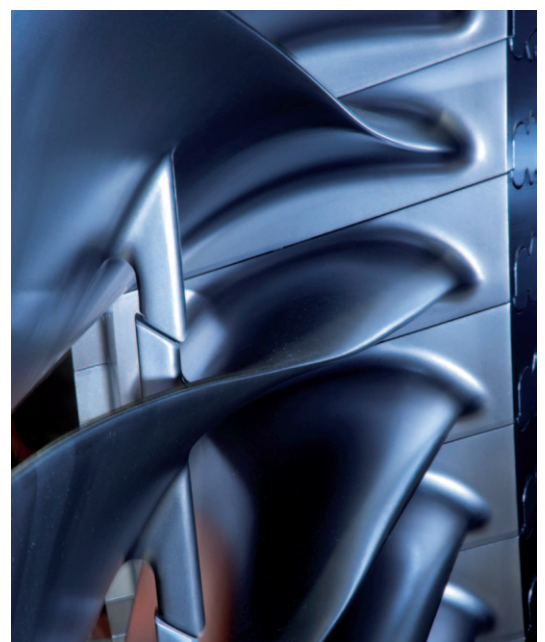
Reshaping the low pressure turbine rotor blades generates additional power.
