OL1&OL2 Annual Outages 2012

CONTENTS

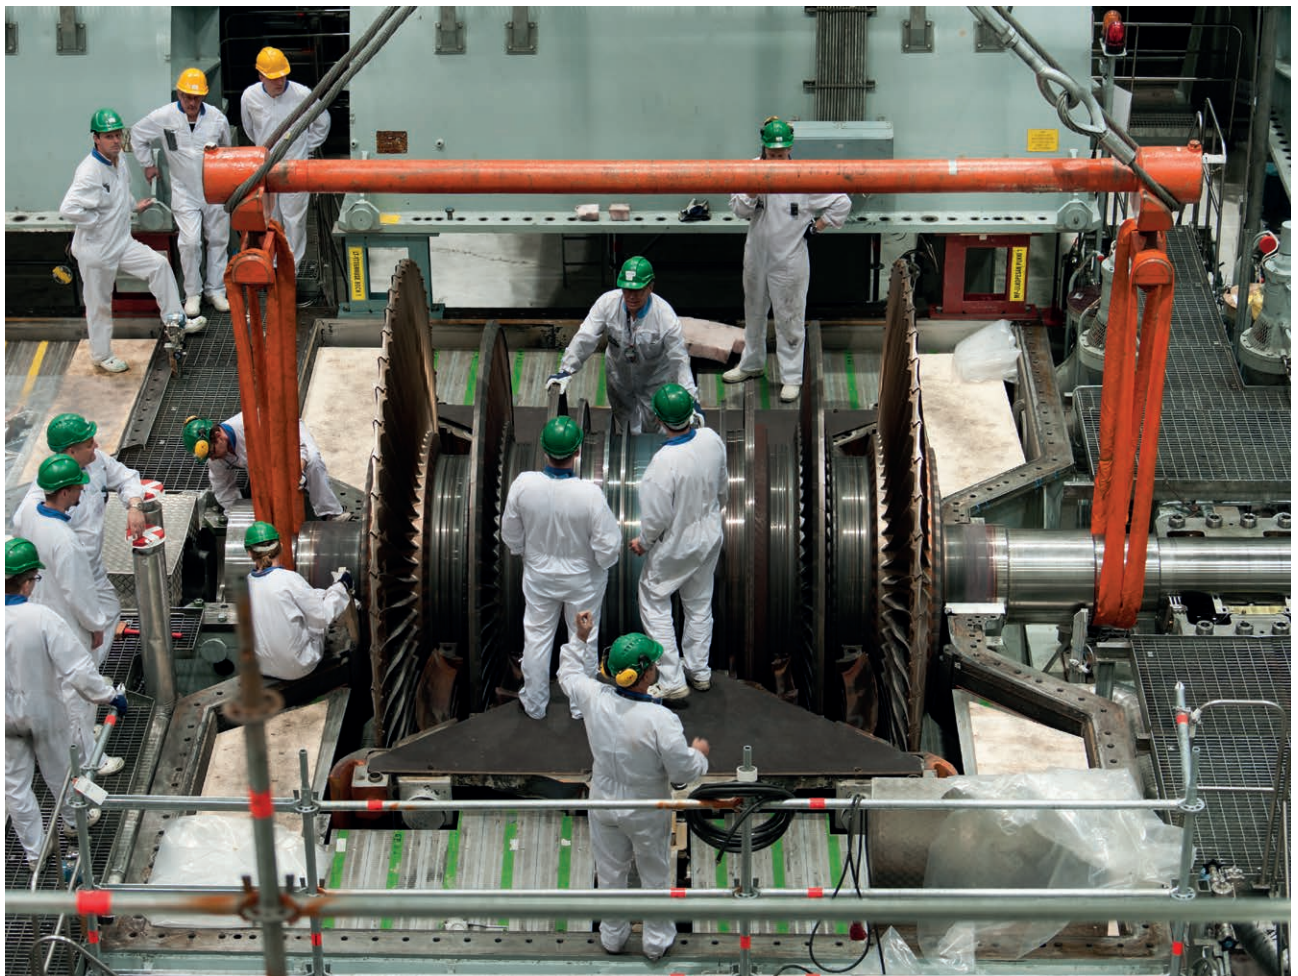
Low pressure turbine work inside the turbine hall.

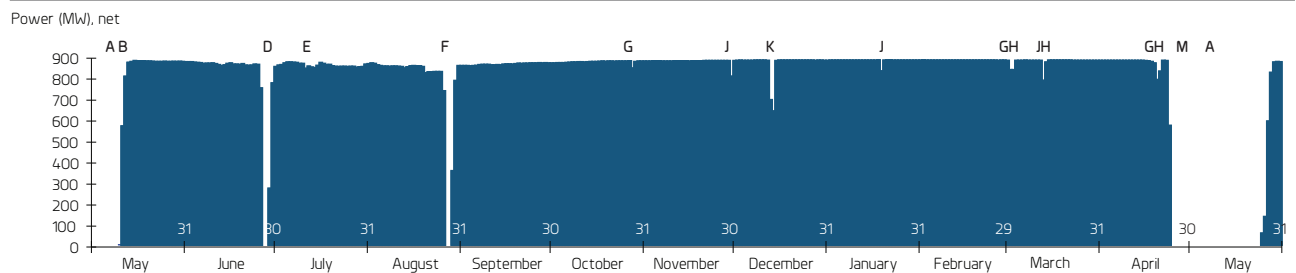
OL1 OPERATION 10 May 2011 to 24 April 2012

A=annual outage, B=repair of dump valve sealing steam leak, C=load decrease during generator tests, D=blow-off system valve inspection and repair, E=recirculation pump malfunction, F=recirculation pump motor replacement, G=periodic test, H=reheater condensate tank flange leak repair, I=closing of main steam valve, J=feedwater pump repair, K=repair of blow-off system differential pressure measurement impulse tube attachment, L=coast-down, M=warm shutdown due to a high moisture level in the generator

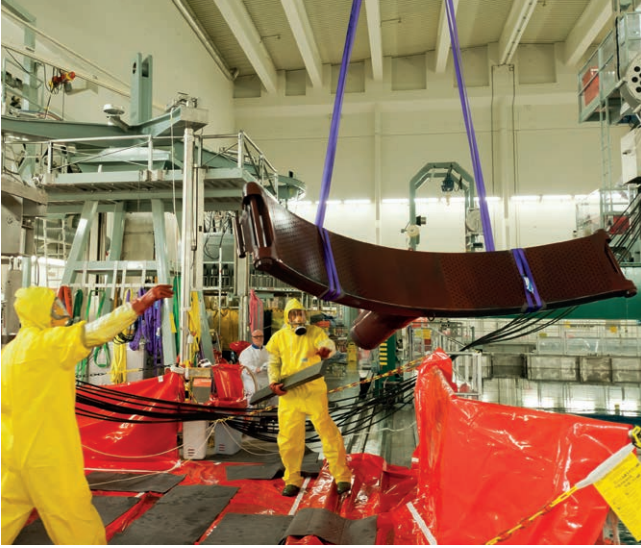
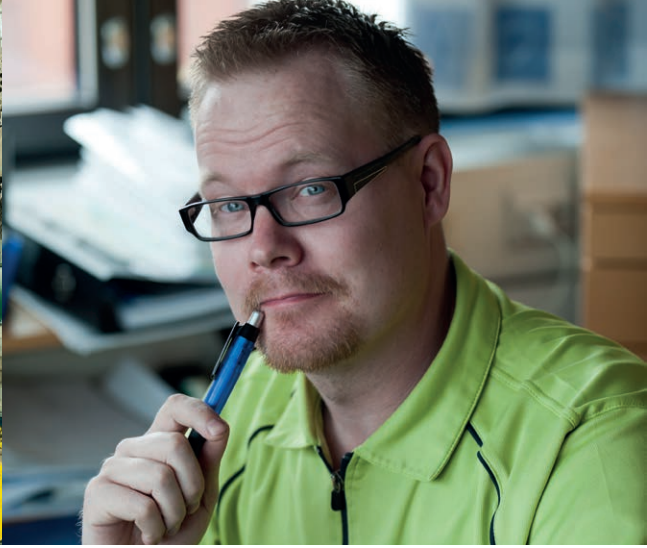
Moving a feedwater distributor for inspection requires special attention.

Two faulty recirculation pumps were replaced during the refuelling outage for OL2. Unlike during normal refuelling outages on the reactor side, a feedwater distributor was also removed for nozzle inspection.

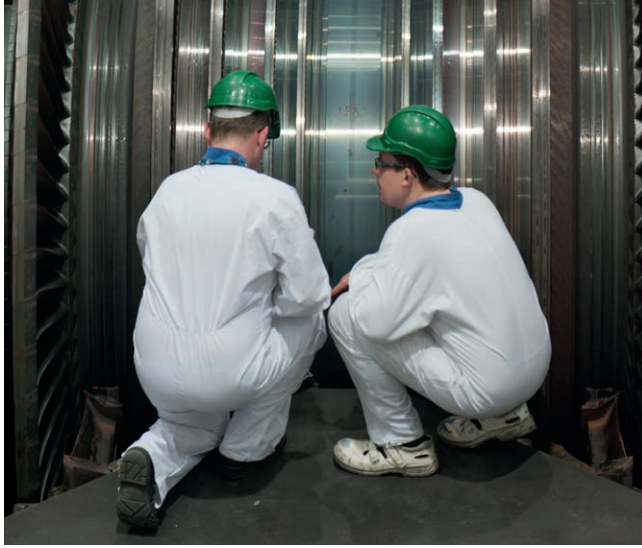
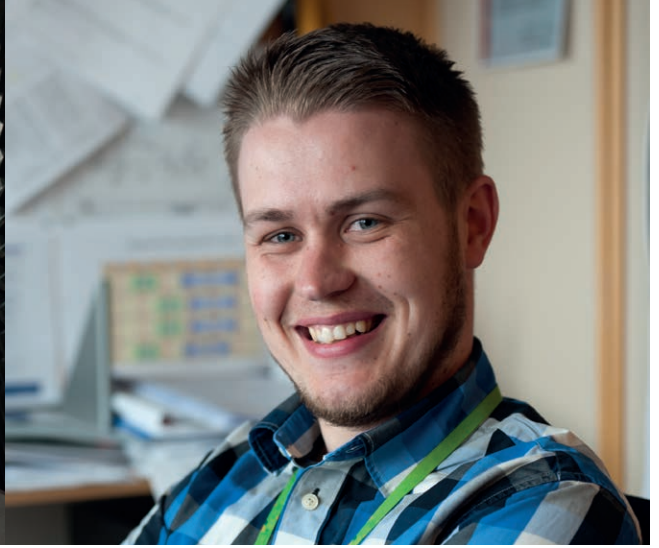
Inspection of the clearance between the rotor and stator vanes on low pressure turbines.

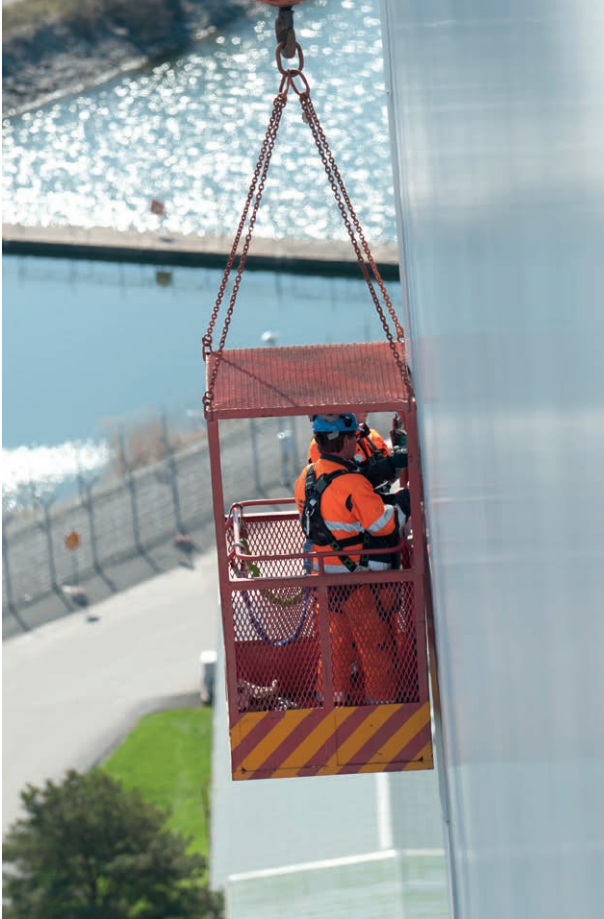
Jukka Berg and Pekka Pösö from Ilmastointi Salminen Oy were cool-headed enough to take a personnel lift to a height of over 60 metres to inspect and install the corner and eave sheets of OL2's reactor building. Fortunately, the weather was kind on the workers.

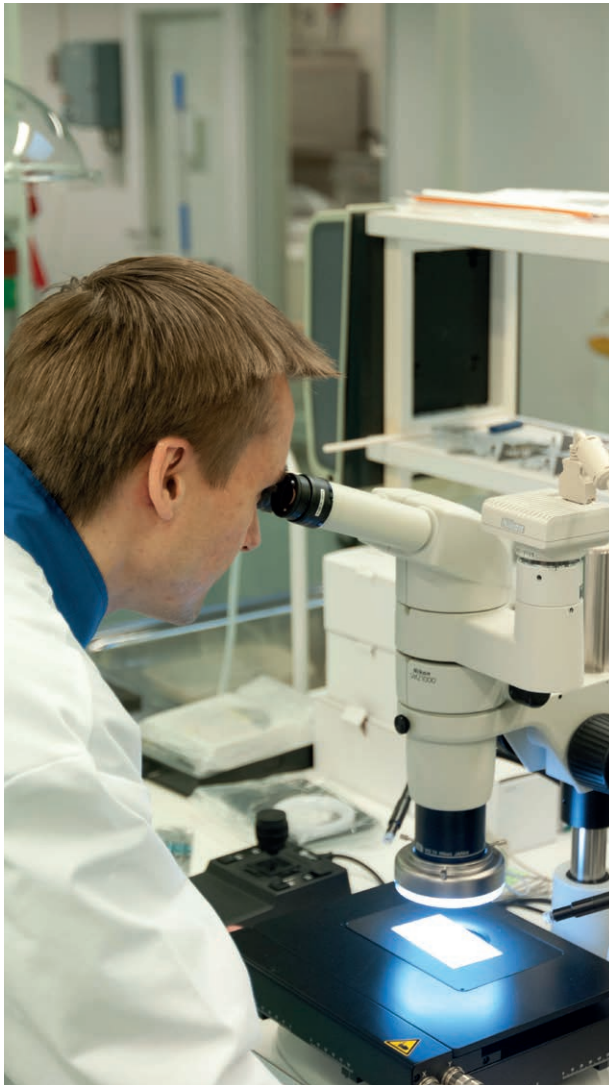
Chemist Jari Vaittinen studying the new remote controlled microscope that arrived in the active laboratory just in time for the outages. The microscope is used for studying radioactive deposits, for example.

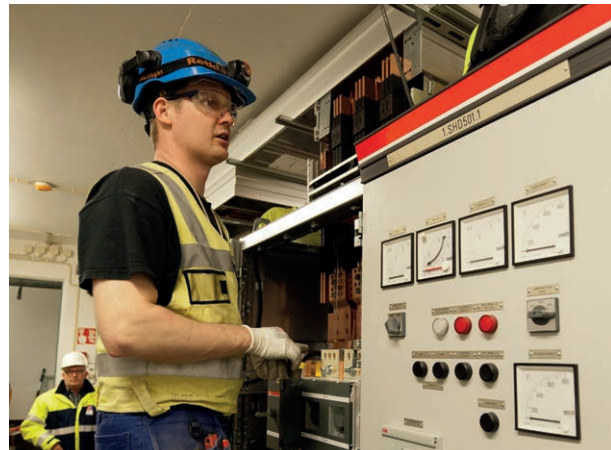
The main switchgear room of the diesel-backed system requires a space of about 150 square metres; this is a large system indeed.
